# Bearing damage and failure analysis

# 1 Bearing life and bearing failures

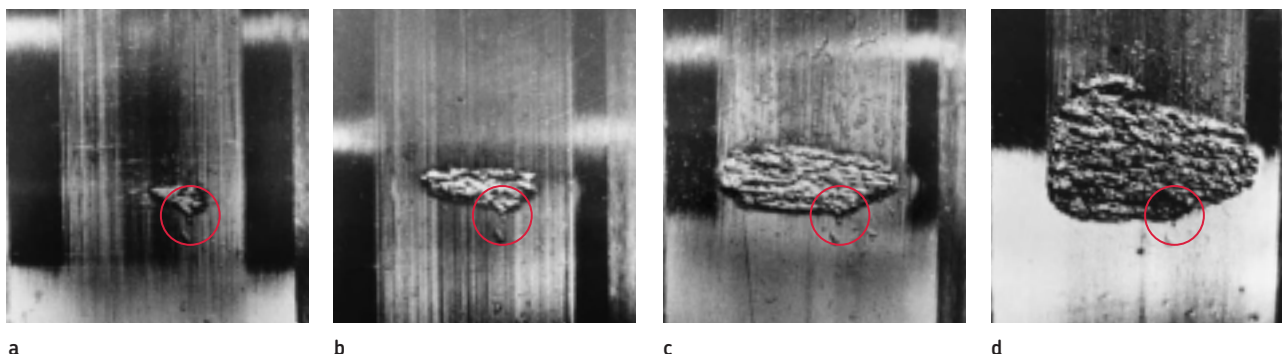
Fig. 1

A hard contaminant was over-rolled and made an indentation in the inner ring raceway of a cylindrical roller bearing (a). The surface initiated fatigue resulting in a spall started just behind the indentation. Over a period of time, spalling became more and more pronounced (b, c). If the machine was not stopped in time, secondary damage to machine components could have occurred. The initial indentation is no longer recognizable (d).

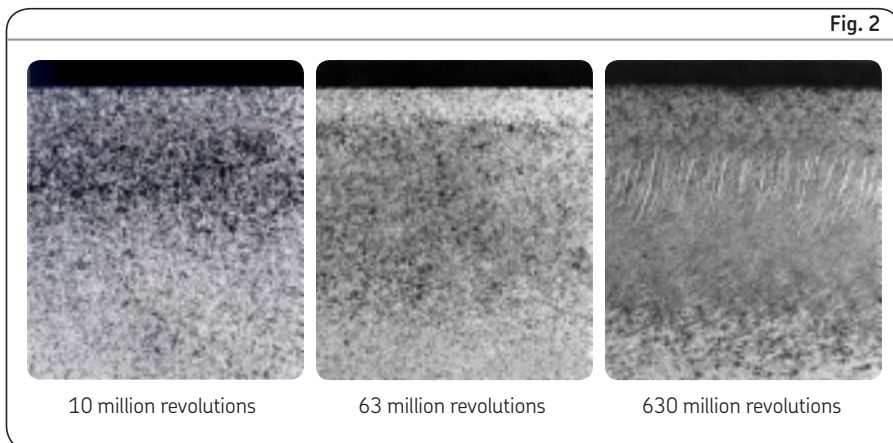
Changes in structure beneath the raceway surface over time (highly stressed, well lubricated small deep groove ball bearing)

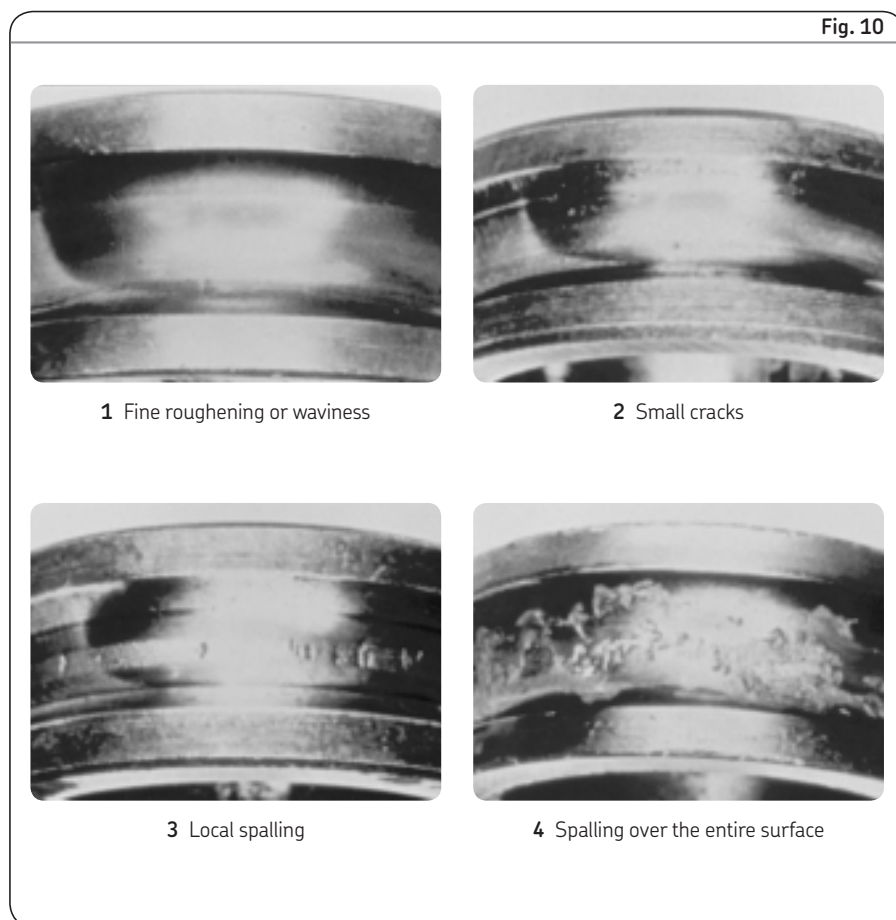
*Progress of surface initiated fatigue on the inner ring of a deep groove ball bearing*

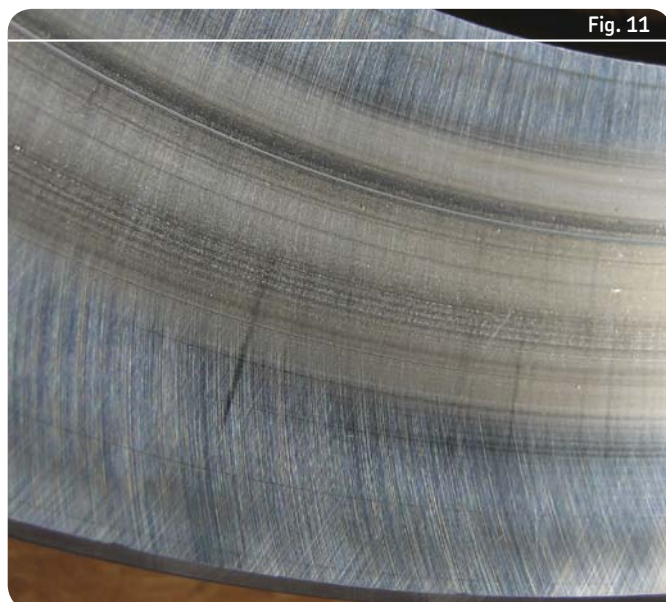
**Light abrasive wear on the outer ring of a spherical roller thrust bearing**

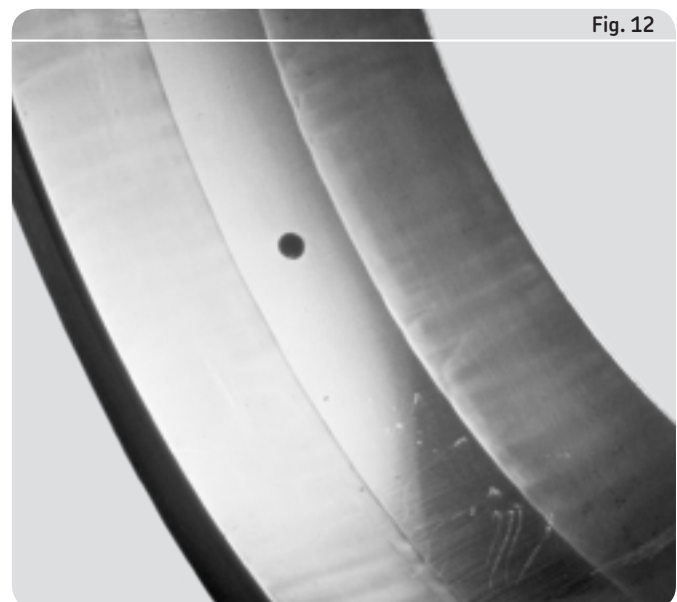
**Advanced abrasive wear on the outer ring of a spherical roller bearing (dull and matt raceways)**

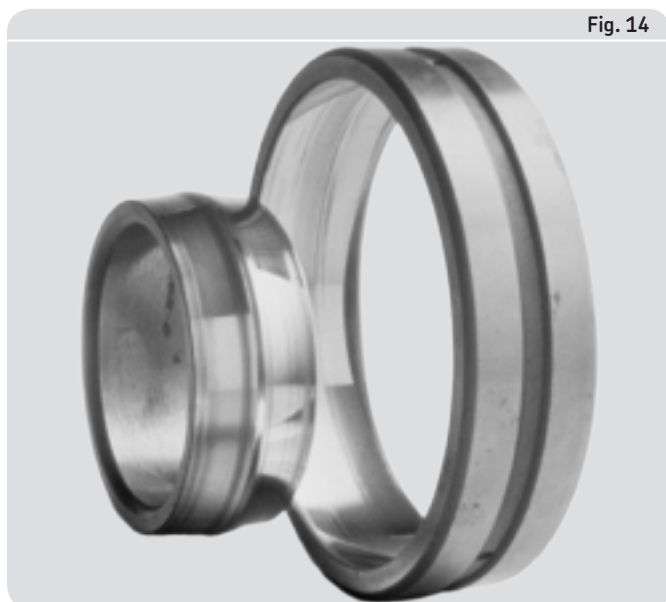
**Fig. 14**

*Polishing wear (mirror-like raceway surfaces) on the inner and outer rings of a spherical roller bearing*

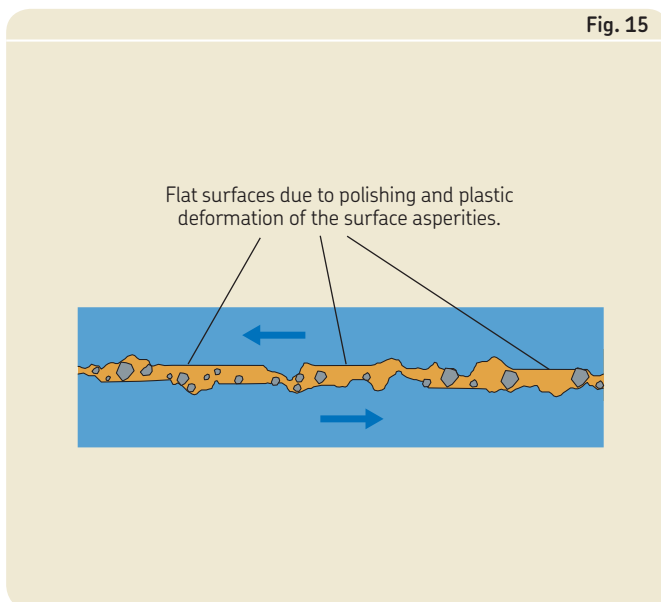
**Fig. 15**

*Process of polishing wear in a bearing*

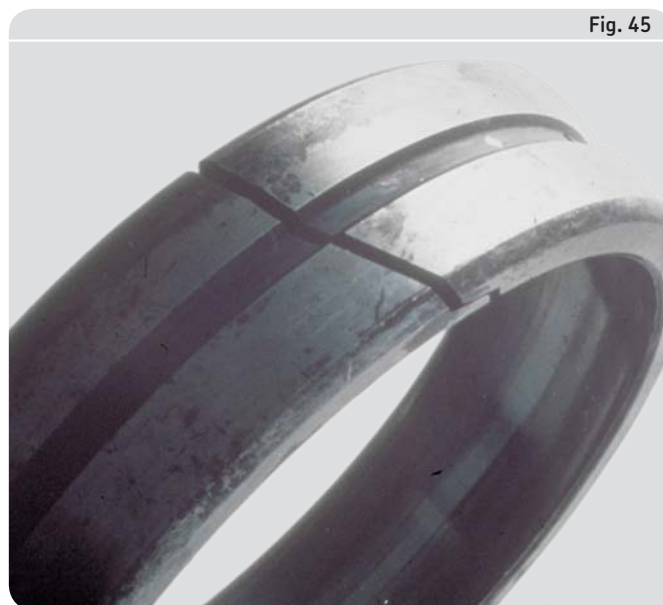
**Fig. 45**

*Fatigue fracture of an outer ring of a spherical roller bearing*

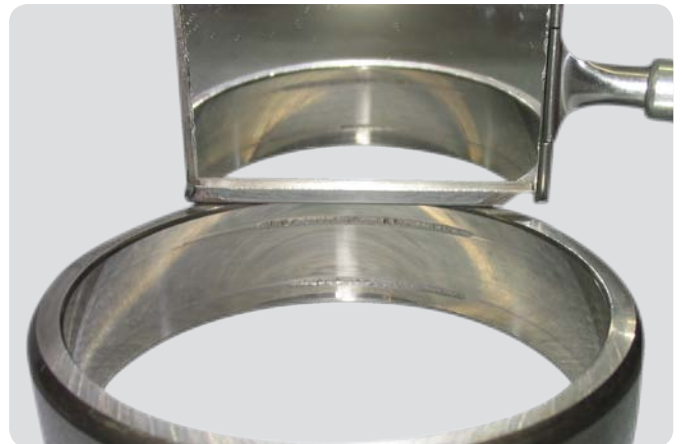
**Tapered roller bearing inner ring**  
Spalling on one side of the raceway only, resulting from misalignment and consequent edge loading, leading to higher stress and failure

- Make sure you have the right bearing for the actual application conditions and their variations (load, temperature, speed, misalignment, mounting, etc.)
- Make sure the lubrication is adequate: right lubricant, right quantity, right time
- Improve the surface separation capability of the lubricant (lubricant viscosity, additives, grease formulation)
- Check the lubricant quality at regular intervals
- Reduce the contamination (improved sealing, oil filtration)

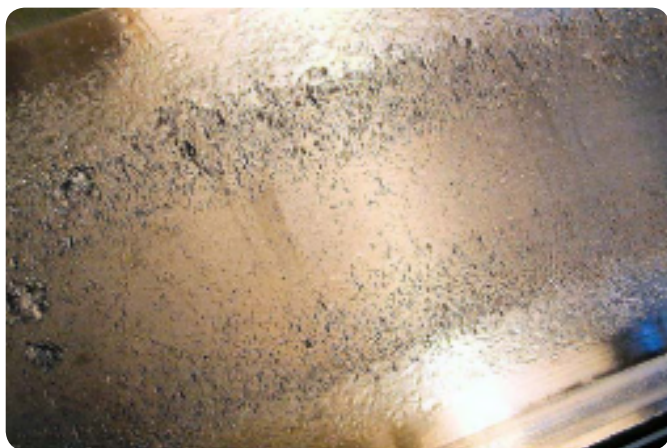
**Spherical roller bearing inner ring**  
*Inadequate lubrication, surface distress with incipient spalling*

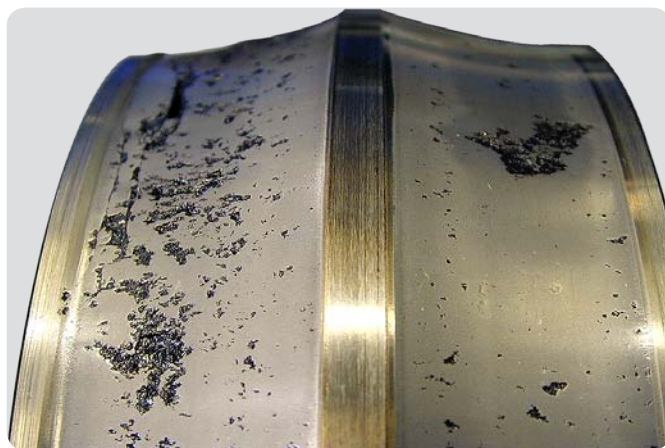
**Spherical roller bearing inner ring**  
*Inadequate lubricant film. Initially, abrasive wear due to contamination, developed into surface distress and spalling.*

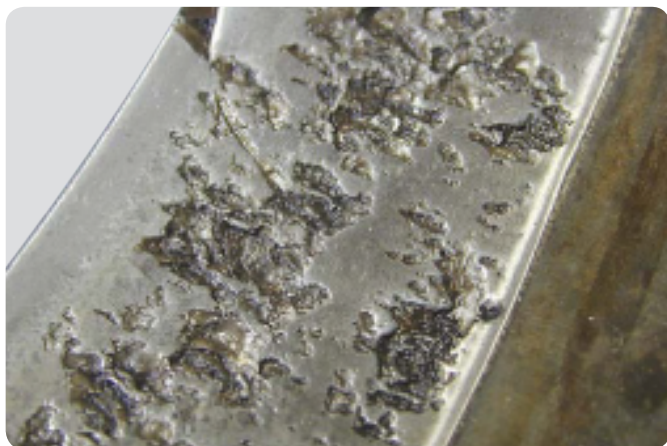
**Spherical roller bearing outer ring**  
*Initially, abrasive wear due to contamination, developed into surface distress and advanced spalling*

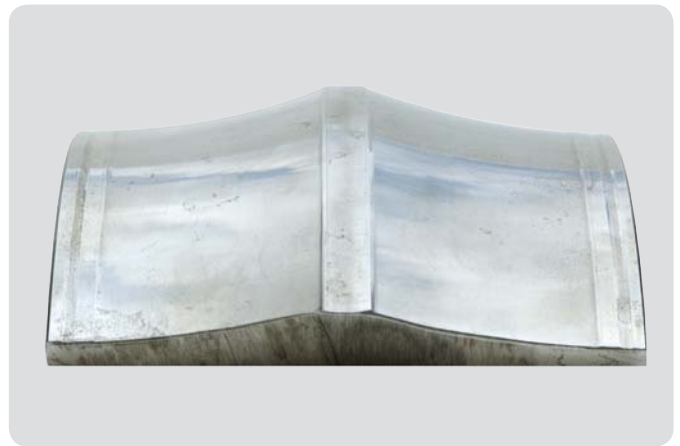
**Spherical roller bearing inner ring**

*Contamination by fine particles – abrasive wear of the raceway tracks – rather shiny. Due to cage pocket wear, a groove has been cut by the cages on either side.*

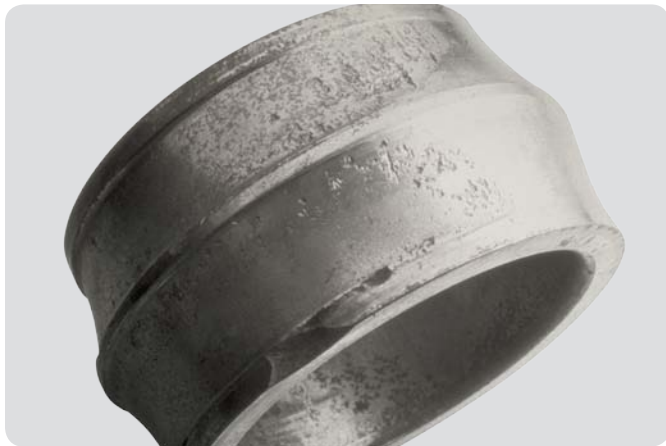
**Spherical roller bearing inner ring**

Contamination and resulting inadequate lubrication leading to abrasive wear of the raceway tracks – one raceway track more damaged due to axial load

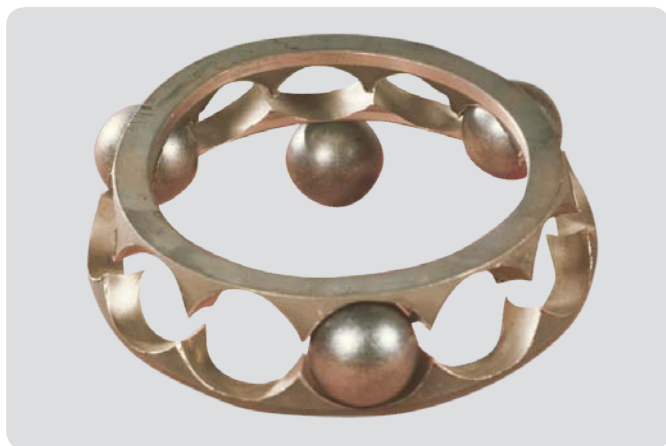
**Angular contact ball bearing cage**

Abrasive wear of the cage pockets due to inadequate lubrication and vibration. Cage bars worn away.

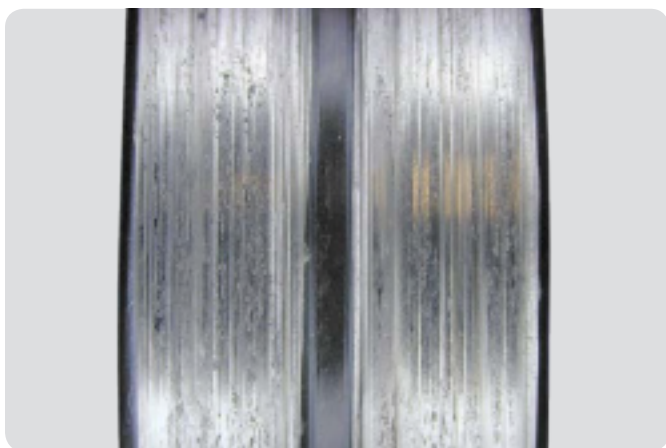
**Spherical roller bearing outer ring**

Ring creep in the housing from inadequate fit – abrasive wear marks on the outside surface

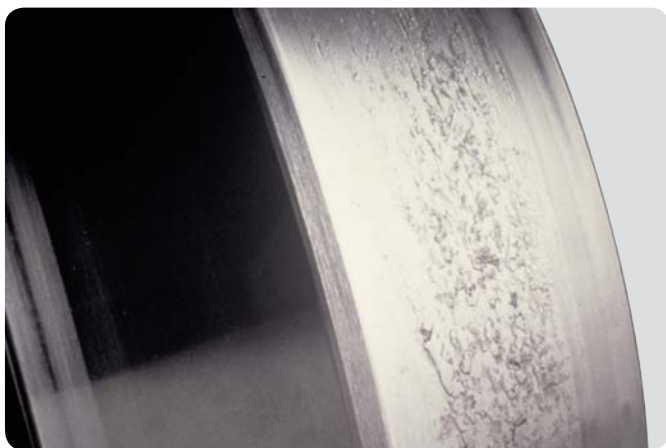
**Spherical roller bearing inner ring**  
*Too low load combined with inadequate lubrication*

- Make sure the bearing is adequately loaded
- Make sure the sealing arrangement is operating efficiently
- Consider bearing downsizing
- Verify lubricant selection (viscosity, AW and EP additives)
- Consider using coatings
- Consider using hybrid bearings

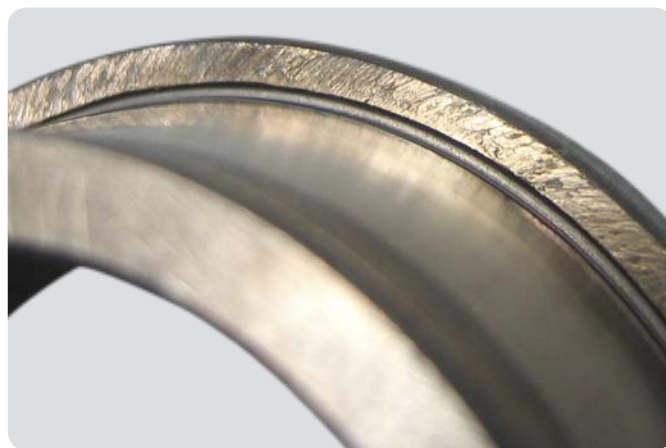
**Tapered roller bearing inner ring**  
*Contamination and inadequate lubrication resulting in adhesive wear of the flange as well as a shiny raceway*

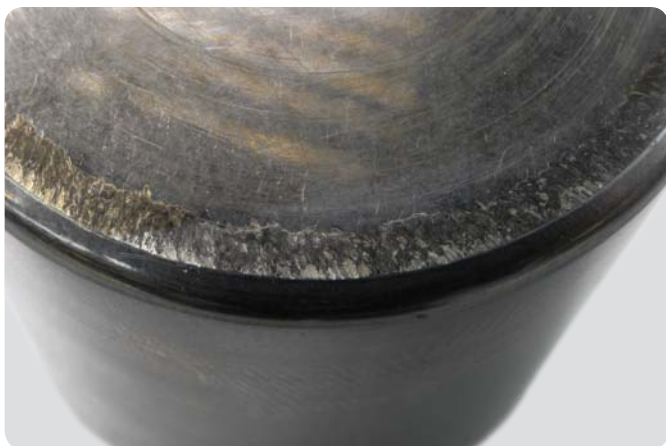
**Tapered roller bearing – roller**  
*Contamination and inadequate lubrication leading to adhesive wear marks on the large roller end face*

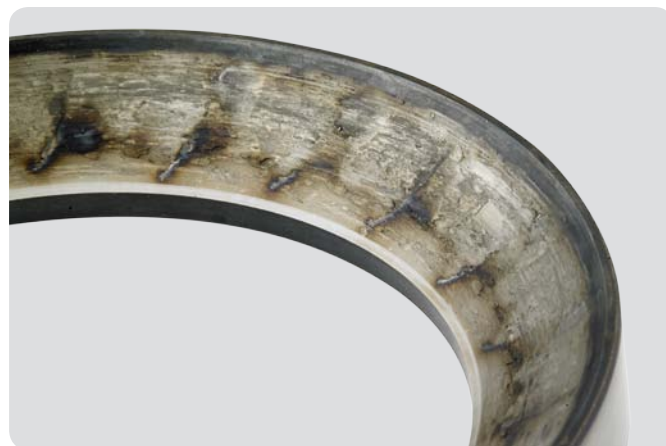
**Spherical roller thrust bearing outer ring**  
*Initially adhesive wear, then excessive heat generation, finally jamming*

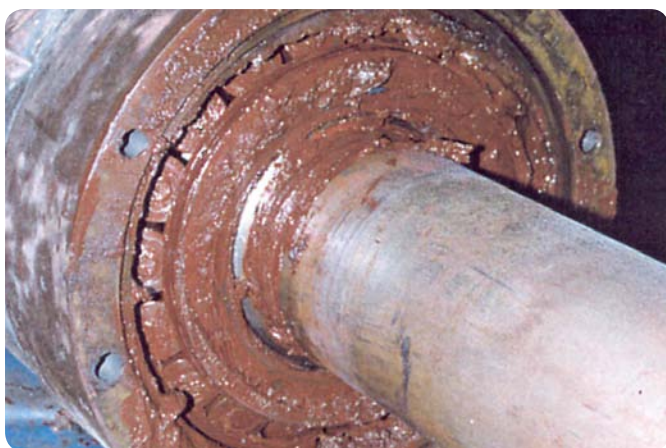
**Tapered roller bearing in a pump unit**  
 Seal failure, bearing corrosion and reddish discoloured grease

- Make sure the bearing arrangement is adequately protected
- Consider using sealed bearings in respect of the operating environment
- Make sure the lubrication is adequate: right lubricant, right quantity, right time
- Do not unpack bearings until mounting them
- Protect mounted bearings adequately

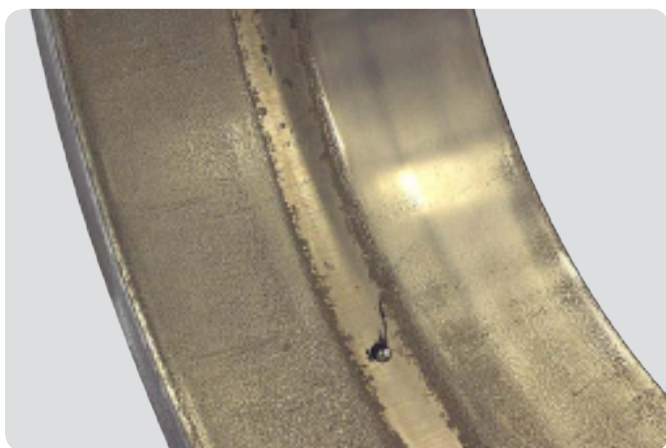
**Spherical roller bearing outer ring**  
 Sealing arrangement failure, corrosive substance entered the bearing

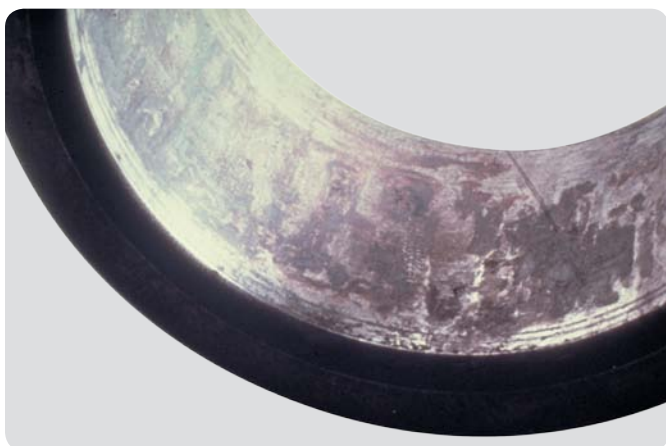
*Cylindrical roller bearing inner ring*  
Inappropriate shaft fit (too loose)

- Select appropriate fits
- Make sure the bearing seats are adequately machined
- Make sure the bearing seats conform to dimensional and geometrical specifications (even after overhaul of the machine)
- In the case of loose fits, consider applying an anti-fretting paste or coatings on one of the bearing surfaces

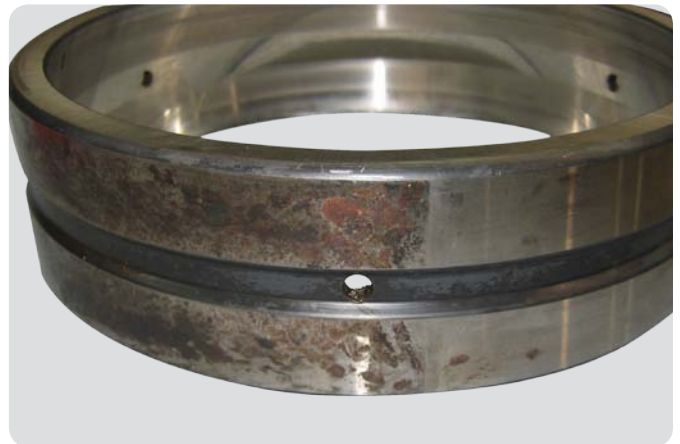
**Spherical roller bearing outer ring**  
Inadequately supported ring

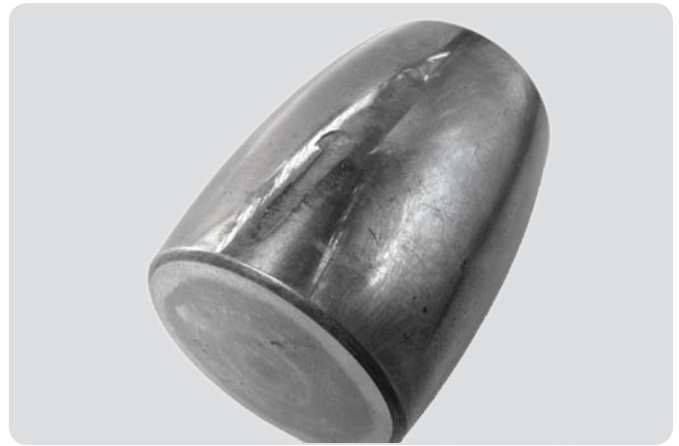
**Spherical roller thrust bearing – roller**  
Heavy impact, plastic deformation

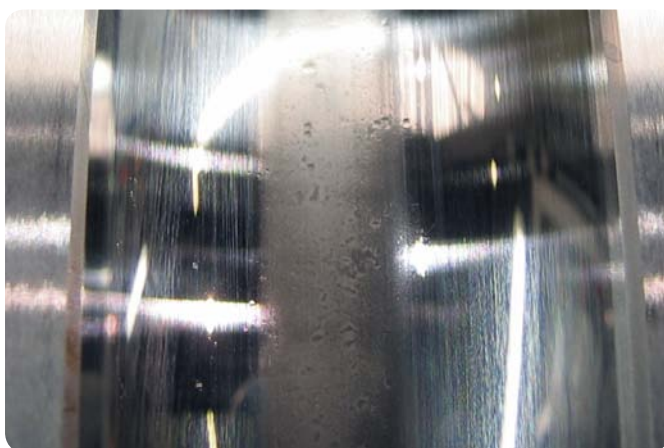
**Deep groove ball bearing inner ring**  
Dents resulting from overrolling of hard particles – inadequate sealing arrangement

- Make sure to work in clean conditions
- Use adequate sealing to protect the bearing
- Make sure the lubrication is adequate: right lubricant, right quantity, right time
- Never drop a bearing
- Treat bearings carefully

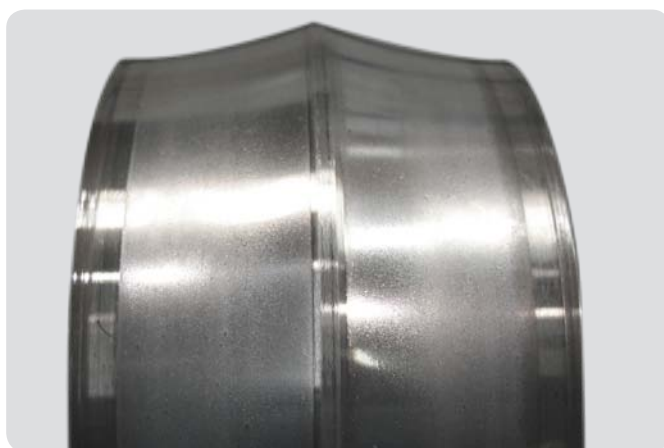
**Spherical roller bearing inner ring**  
Many small dents resulting from overrolling of small hard particles – inadequate sealing arrangement

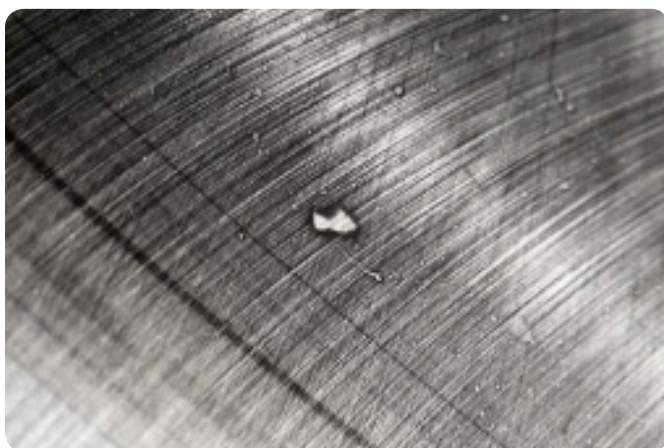
**Spherical roller bearing outer ring**  
Overrolling of hard particles that entered the bearing during mounting – lack of cleanliness

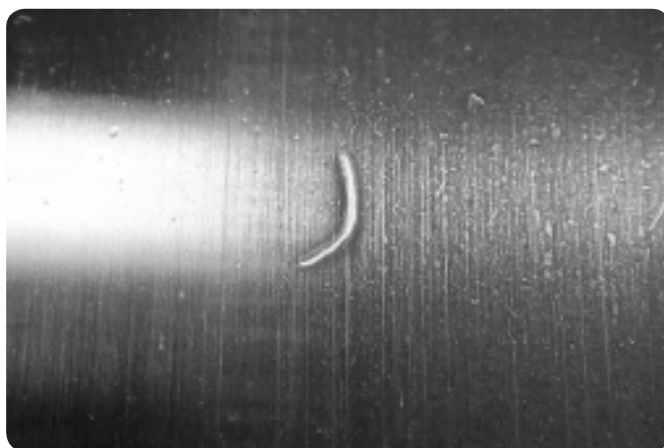
**Spherical roller bearing outer ring**  
Overrolled swarf/chip will lead to spalling

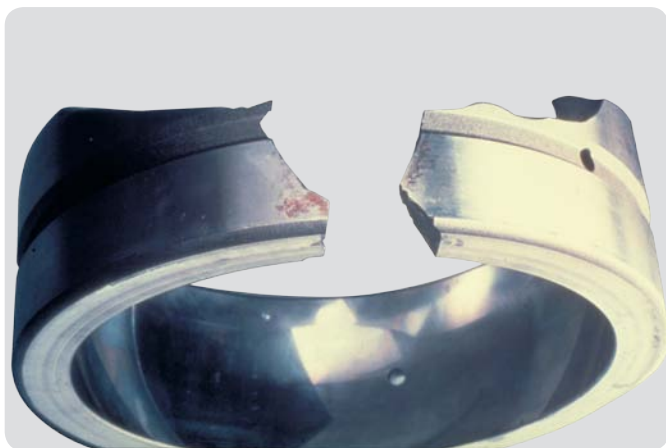
**Spherical roller bearing outer ring**  
*Fatigue fracture resulting from inadequate housing seat (swarf trapped at the bottom of the housing)*

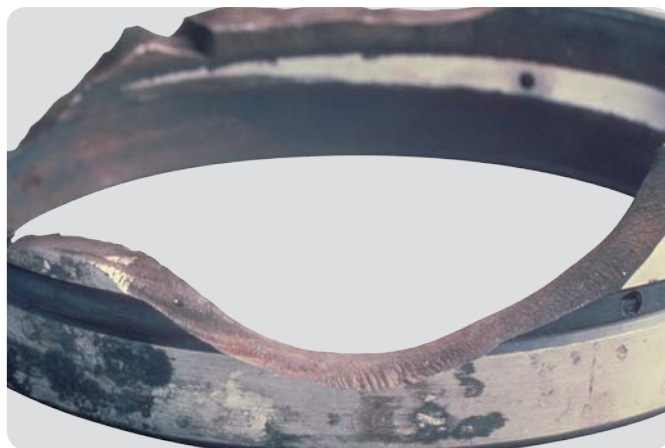
**Spherical roller bearing outer ring**  
*Inadequate housing seat leading to fretting corrosion and finally fatigue fracture*

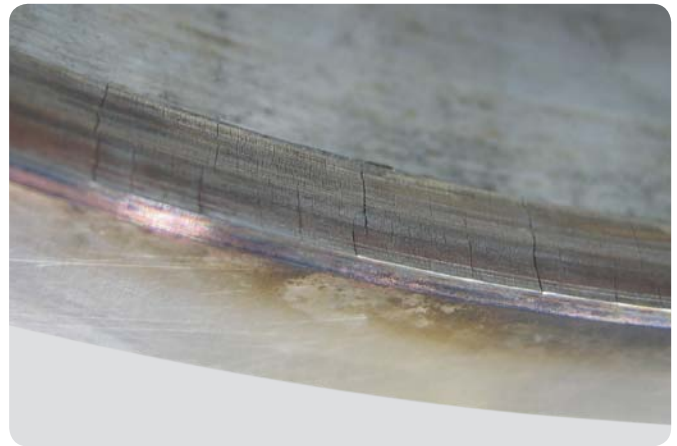
**Cylindrical roller bearing outer ring**  
Thermal cracks at shoulder-cage contact due to inadequate lubrication
